**SHE Alerts 0052**

SHE Incident Alerts

3800/FOR/0052

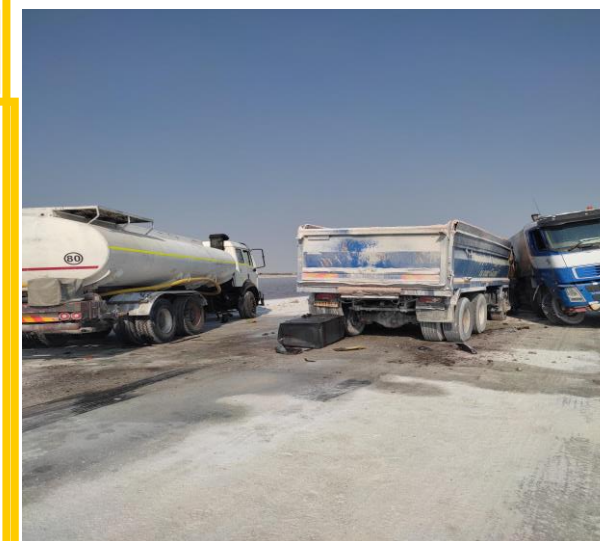
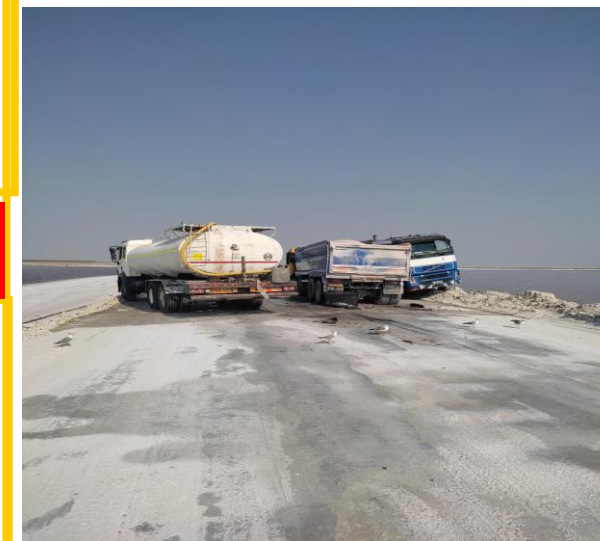
An Edgeworks Inc tipper truck (S26) hit a water bowser and tipper truck (S25) which had stopped in the middle of the haul road between NS and X1 ponds.

- 100L of diesel spilled on the haul road
- S26 truck operator sustained right hip joint sprain and multiple bruises.

- Operators were also tested and the results were negative.
- All operators were in possession of valid authorizations.
- Pre Start Checklists of the trucks were done.
- Non adherence to Use of Company Vehicle Procedure;
 - Water bowser and tipper truck (S25) stopped in the middle of the haulage road.
 - Skid marks (20m) from tipper truck (S26) indicate that the truck was travelling above the stipulated 40 km/hr.

- The activity was immediately stopped, and relevant authorities were notified.
- The injured was taken to the clinic for further assessment
- Edgeworks Inc employees were briefed on the incident and Use of Company Vehicles Procedure.
- The contaminated soil was removed and taken to Salvage Yard.
- Employees must adhere to safety procedures.
- Supervisors must enforce safety procedures in their areas of responsibility.
