**Safety First !****SHE ALERT****SAFETY Communication****Pictures****Classification**

Property Damage

Where?**Section:**Fabrication
Workshop**Equipment:**

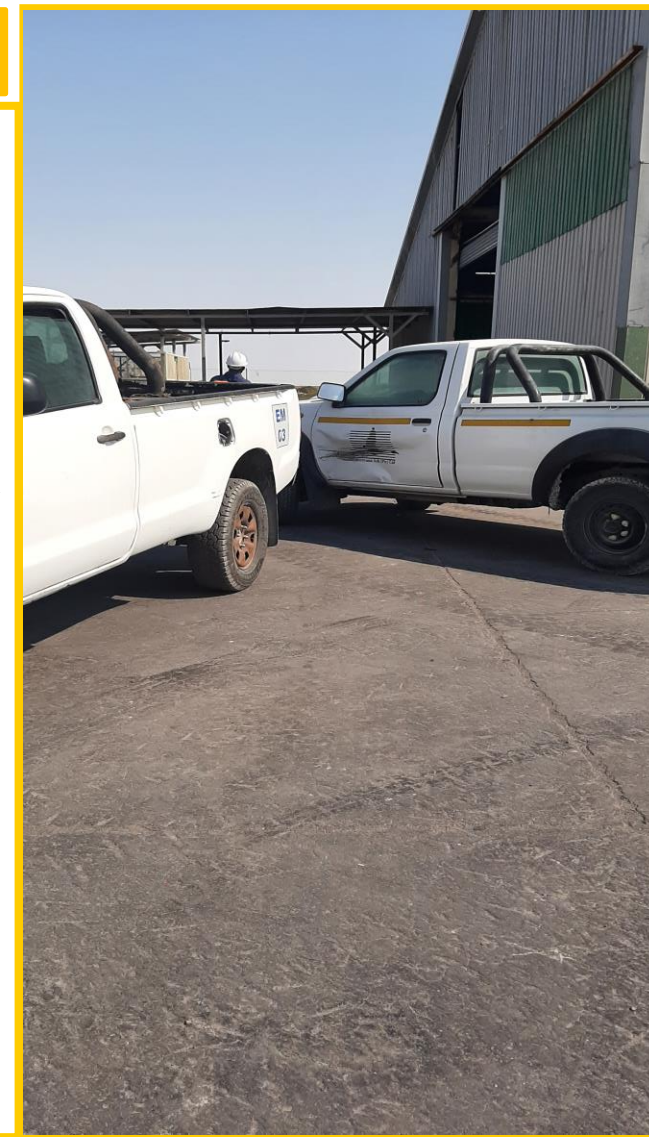
The two vehicles collided whilst both were reversing, one was departing and the other was attempting to park at the Fabrication workshop.

- Drivers' authorization for both drivers is valid.
- Vehicle pre-start checklists were conducted.
- Drivers were also tested and results were negative.
- Non-adherence to procedure- The driver departing workshop had not parked in reverse as required.

Door panel and rear bumper

1. Activity was stopped immediately.
2. Incident scene was secured.
3. Incident was reported to relevant authorities
4. Employees should always adhere to procedures.
