**Safety First !****SHE ALERT****SAFETY Communication****Pictures****Classification**

Property Damage

Rigging Workshop

Shuttle Lift (Small Crane)

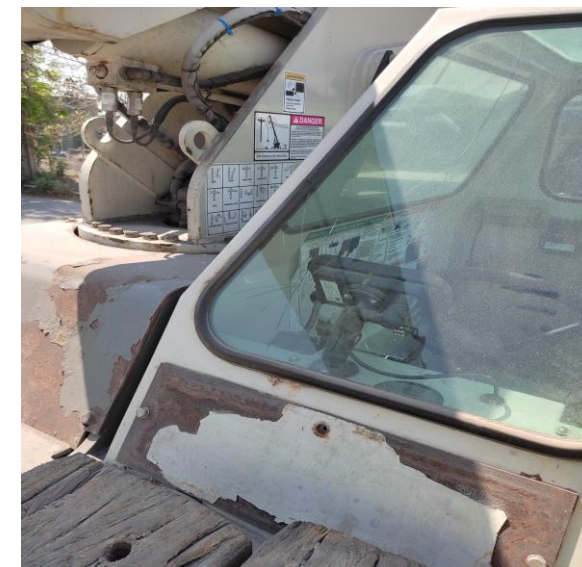
Whilst loading a 5 meter wire sling on top of the shuttle lift's platform the sling hit the windscreen.

- The rigger was also tested and the results were negative.
- The rigger was not attentive whilst putting the sling top of the shuttle lift's platform.
- The sling hit the front windscreen and cracked it.

Cracked front windscreen

- The activity was immediately stopped.
- The incident was reported to the relevant authorities.
- Employees of the section were briefed on the incident.
- Employees must always be attentive when they execute their duties.
