SHE Management Incident Investigations SHE Incident Alerts

SHE ALERT

Soda Ash Compaction

Pre-Roller Crushers

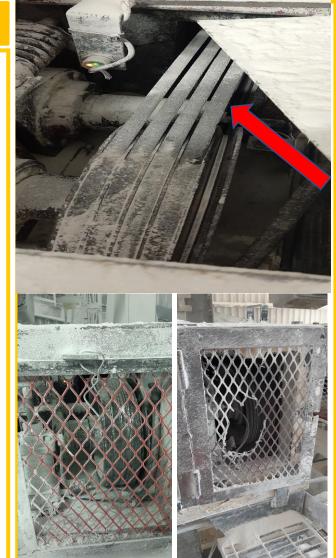
A Plant Operator's 4th right finger got trapped between the v-belt and pulley whilst trying to reverse the crusher manually.

The Plant Operator did not follow the operating process of reversing and forwarding the crusher at the sub station when there is a choke.

The injured tried to reverse the crusher by pulling the V belt manually as opposed to using the crusher reverse mechanism at the sub station.

Most of the guards at the Soda Ash Crushers have been damaged, this is unsafe as it exposes employees to rotating machinery which can cause serious injuries.

- 1. Activity was stopped
- 2. Incident was reported to the relevant authorities
- The injured was taken to the mine clinic for further assistance
- 4. Brief all employees of the section
- Replace all damaged guards within the plant.
- 6. Tampering with protective devises is prohibited.
