Restricted Work Injury

SHE ALERT

A UNIDEV employee sustained an injury on his right middle finger after his hand got trapped between two concrete slabs whilst trying to load them onto a TLB bucket.

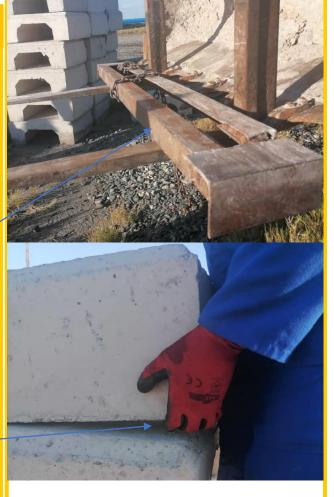
- Non-Adherence To Procedure A second TLB without forks was expediated to fast-track the works which resulted in the employees manually loading the slabs onto the TLB bucket.
- The employee was wearing protective gloves.

The steel bar & chain method was initially introduced to avoid the manual loading of concrete slabs

Employee lifting the slab by placing his fingers in a nip point.

- First aid was administered on-site, and the injured was taken to the mine clinic and later transported to Francistown for further medical assessment.
- The incident was briefed to section employees.
- Employees must always adhere to safe work procedures and supervisors must ensure that their teams are complying with approved method statement.
