SHE Incident Alerts

SHE ALERT

Whilst clearing the ground behind Fabrication Workshop Storeroom for backfilling, the TLB front bucket severed an electrical supply cable to the Sewage Treatment Plant.

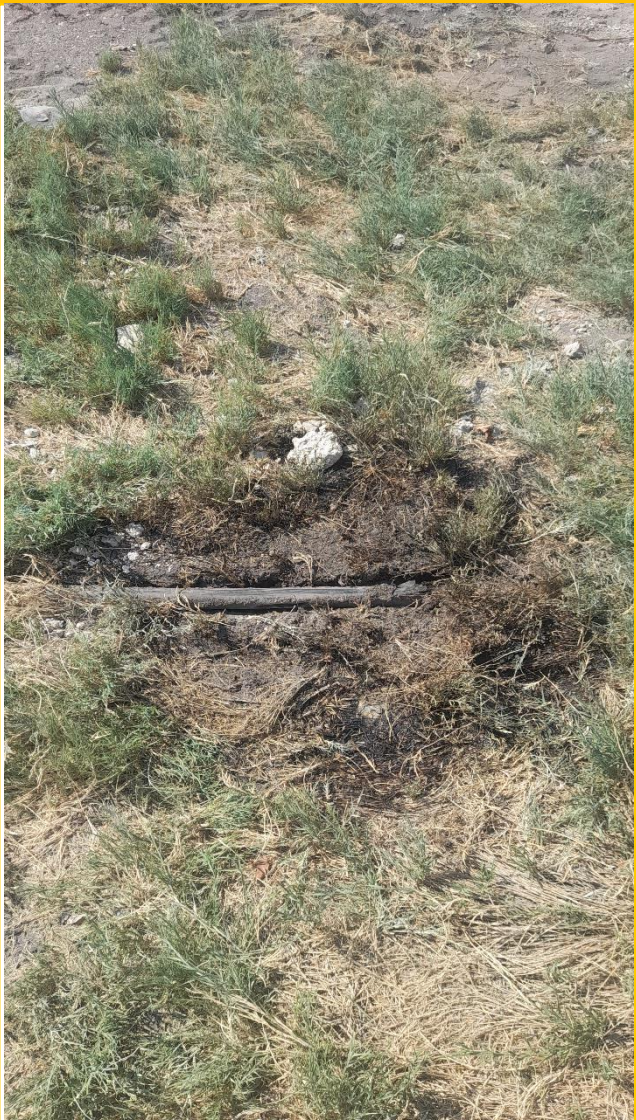
Severed Electric Supply Cable

- Electric supply cable was exposed as it was not buried underground.
- Risk assessment was inadequate as some hazards were not identified.
- A thorough physical assessment of the area was not done before starting work.
- Approximately a square meter of grass was burnt, and an electrical cable was severed.
- The TLB Operator used water to extinguish an electrical fire.

- The activity was stopped and the incident was reported to relevant authorities.
- All power electric cables should be buried underground, to prevent risk of fire.
- Fire awareness training to be conducted across the mine to sensitize employees on ways of extinguishing different types of fires.
- Thorough physical and risk assessments to be done before start of work.
