SHE Alerts 0052 **SECTION** SHE Management SUB-SECTION Incident Investigations **SUBJECT SHE Incident Alerts**

**SHE ALERT**

**Location**: Soda Ash Plant – Bagging

**Date**: 06/05/2023

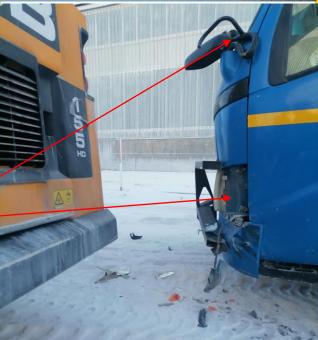
Truck left mirror and indicator lamp.

- along the road, a Bobcat operator **Tailgating**: The truck driver drove too close to the Bob cat.
  - The Bobcat operator reversed without looking behind to check for oncoming vehicles.
  - Both truck and Bobcat operators had valid driver authorizations.
  - Alco tests were done on both employees and results were negative.

Damaged indicator lamp and side mirror of the truck

- The incident was reported to responsible personnel
- The incident was briefed to employees of the section.
- One must maintain safe following distance when driving behind other machinery in order to avoid harm should thee.
- Operators of mobile machinery must always check for on coming vehicles before reversing on the road.
