Property Damage

Water pipeline – Near

SHE ALERT

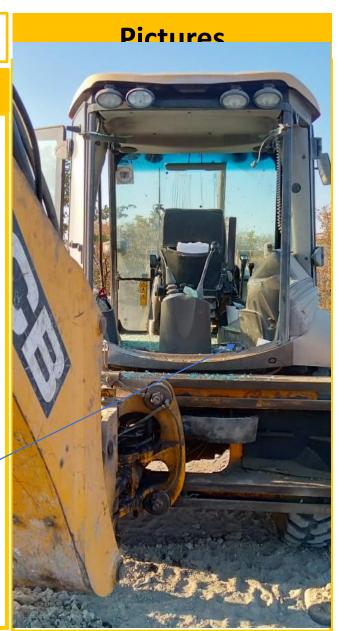
Whilst positioning a TLB to excavate a trench for installation of portable water pipeline, the rear wind screen of the TLB got shattered.

- Defective Equipment- The TLB back wind screen shuttered whilst the equipment was in operation.
- The operator had a valid authorization.
- The operator was alco tested and results were negative.

Shattered wind screen of the TLB

- The incident was reported to responsible personnel
- The incident was briefed to employees of the section.
- Garage to engage in the Original Equipment Manufacture (OEM) to establish possible causes for defects in mobile machinery.
