Property Damage

Location: WIO

SHE Alerts 0052
SECTION
SUB-SECTION
SUBJECT

SHE ALERT

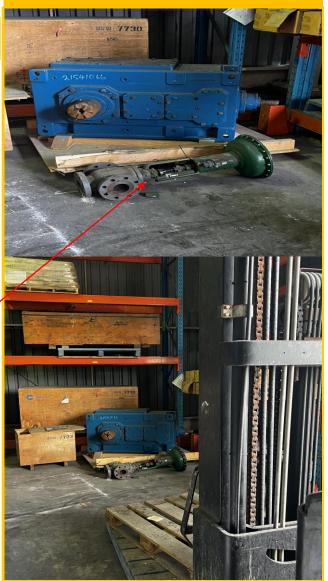
While the Forklift Operator was trying to stack a three-way globe valve into a rack, it slid, fell, and broke the body York of the actuator, and bent the valve plug.

Broken three-way globe valve and bent valve plug

- The three-way valve was not secured to the pallet hence it slid and fell as it was lifted to a height of more than 2.3 meters above ground.
- The Risk Assessment was done, and the hazard was also identified and mitigated by availing a spotter.
- The alco test was done, and the results were negative.
- The Operators authorization was valid

Broken Threeway Valve

- Work was stopped immediately.
- Where possible heavy materials should be stacked on lower racks.
- Secure loose items to the pallet before loading to avoid slips and falls.
- Employees must always adhere to safe work practices and supervisors must ensure that their teams adequately mitigate risks identified.
