SHE Alert

SHE Incident Alerts

EL&L truck registered B876 BBO slipped and drove into the culvert opposite the Salt Plant Workshop while on its way to offload coal.

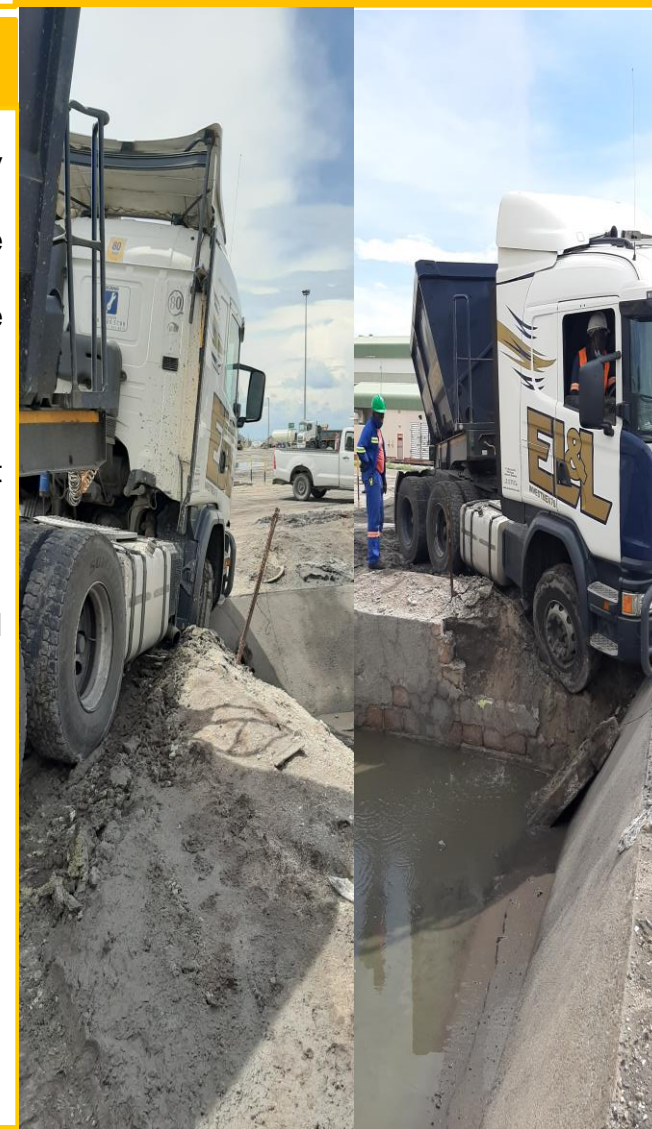
Culvert broke off

- The road condition was wet and slippery due to the recent rains, thus causing the trucks right front wheel to slide into the culvert.
- The intersection is narrow making it difficult for trucks with trailers to turn.
- The truck driver was also tested and results were negative.
- There is no chevron at the intersection.

- The incident was reported to relevant authorities.
- Other road users were notified to use alternative routes.
- The truck was removed from the incident scene.
- Chevrons signage was installed at the intersection.
- Drivers urged to exercise extra caution when driving in muddy conditions.
- The intersection joining Salt Plant, Stewart Motors and Utilities needs to be increased.
