## SHE Alert

SHE Incident Alerts

Soda Ash Plant

I-Beam

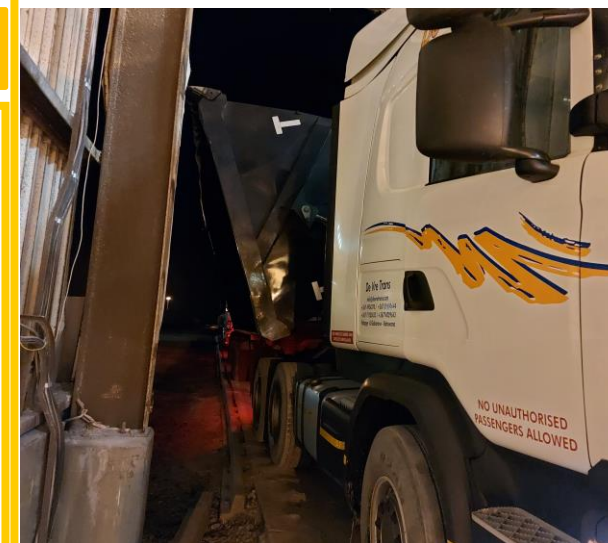
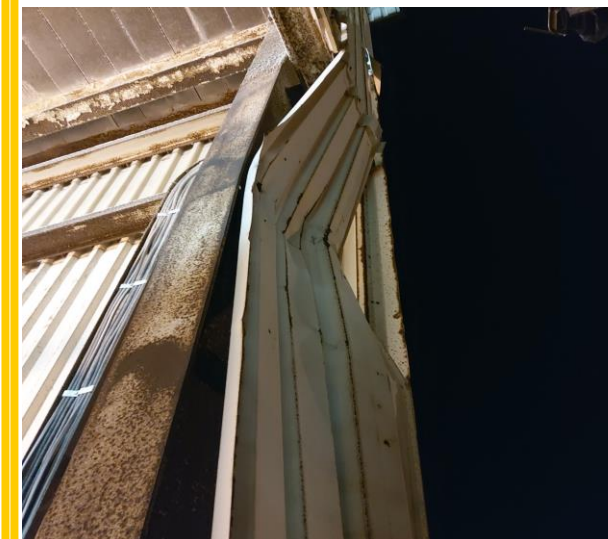
A De Vre truck hit and damaged the I-Beam structure supporting the ash bagging first floor with a tilted loading bin.

Deformed I-Beam

- Upon arrival at the loading bay, the driver was instructed to tilt the loading bins for inspection by the Packaging Attendant.
- After inspecting the loading bins, the Packaging Attendant proceeded to inspect other trucks without informing the driver to return the loading bins to normal position.
- An hour later the truck driver was instructed to enter the loading bay for loading.
- The driver of the truck had dozed off whilst waiting for his truck to be called in for loading.
- Prior to entering the loading bay, the driver did not check the position of the loading bins and as a result the tilted front-loading bin hit and damaged the ash bagging first floor I-Beam structure on Line 10 .

- The bulk loading activity was stopped, and the incident was reported to all relevant people.
- Ash Bagging supervisors to brief their crews on the incident.
- Improve on illumination around the ash bagging facility to improve on driver's visibility .
