## SHE ALERT

Salt Mechanical

LDV- B 858 BFP

**Date:** 21/03/23

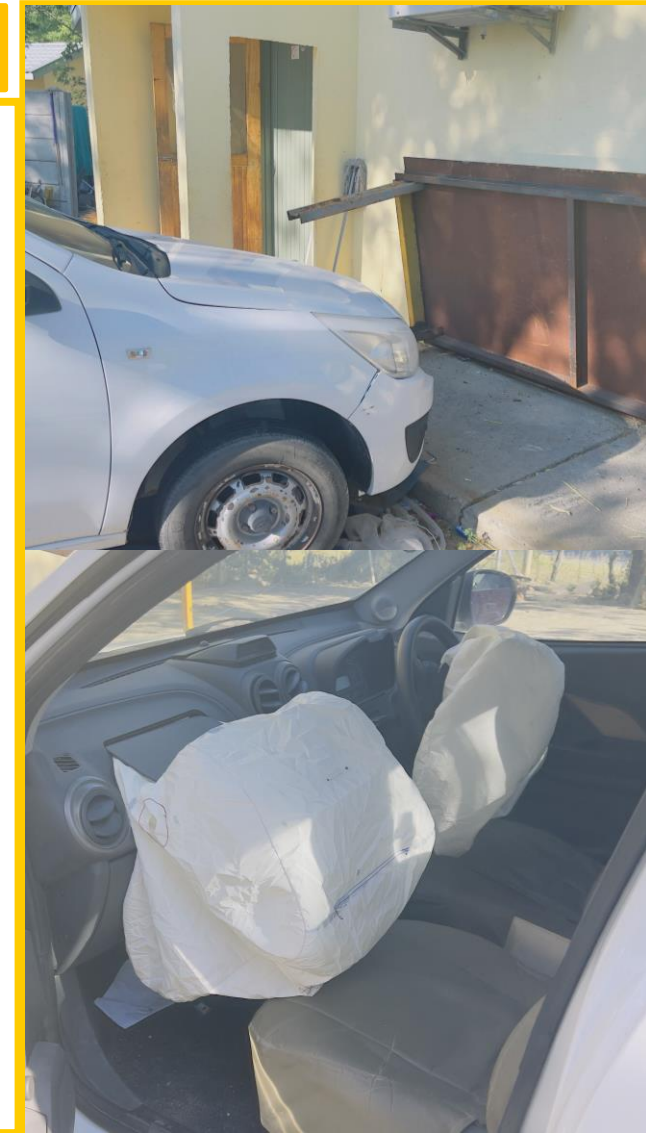
A Salt Plant mechanical light duty vehicle (LDV) upon being started on gear, jerked and hit a steel workbench denting bonnet and front grill.

Front grill and bonnet

- The vehicle was parked on gear while the handbrake was disengaged.
- The driver started the vehicle whilst standing outside and it jerked forward hitting a steel workbench.
- The vehicle was not wheel chocked.
- Due to the impact, both the driver and passenger airbags were activated.
- The driver was alcohol tested and the result were negative.
- The driver is in possession of a valid authorization.

1. To prevent accidental movement of the car when starting;
  - Ensure that the car is on neutral by waggling the gear stick side to side.
  - Press down the clutch and brake pedal
2. When parking, ensure that the handbrake is always applied
3. Always apply wheel chokes when the car is parked
