SHE Alerts 0052

SHE Incident Alerts

SHE ALERT

Location : Soda Ash Offloading – Line 11

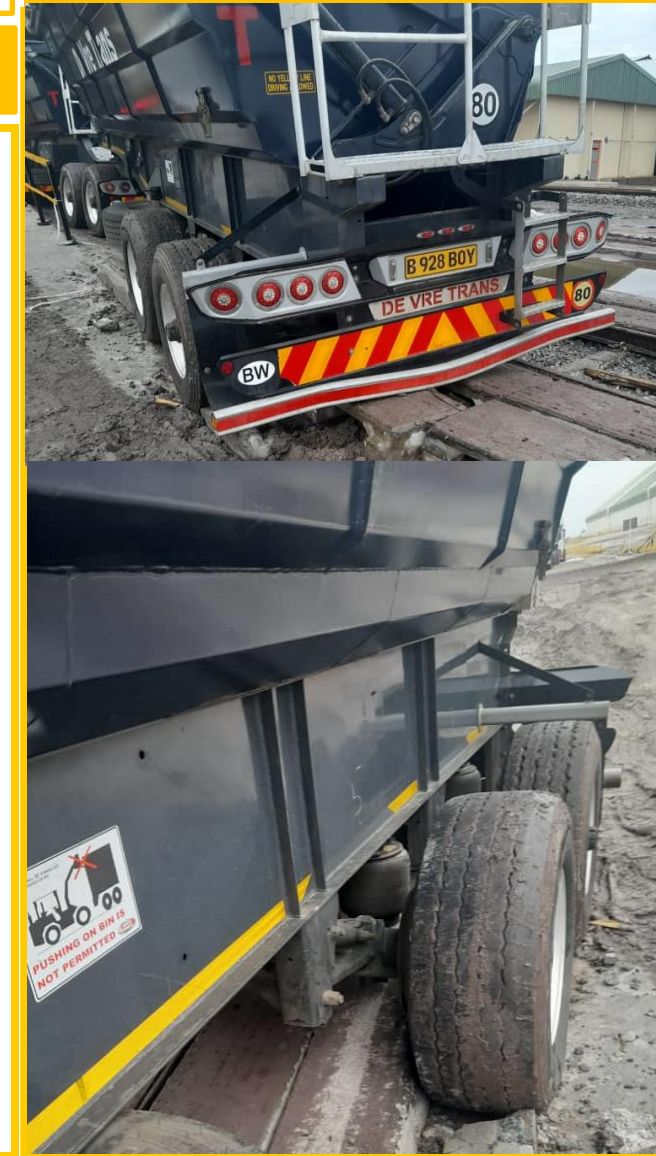
A customer truck slipped off and its left rear trailer wheels got in between the railway line whilst trying to align for loading at Soda Ash Loading Bay.

- Damaged concrete slab blocks

- The truck Driver was in possession of a valid authorization.
- The Driver was also-tested and the results were negative.
- **Unsafe Act-** The Driver used the wrong entry to access the loading bay.
- **Negligence** – The Driver continued to drive the truck despite realizing that there was no allowance for the rear trailer.
- **Unsafe condition** – The slab blocks on line 11 are inadequate to cater for trucks.
- **Weather Condition** – The incident was aggravated by wet conditions due to rain.

- The truck was stopped, and the incident was reported to all relevant authorities.
- The incident was briefed to employees of the relevant section.
- A risk assessment was conducted, and the truck was removed successfully.
- Truck drivers are to use designated points at the loading area.
