**SHE Alerts 0052**

SHE Incident Alerts

**3800/FOR/0052**

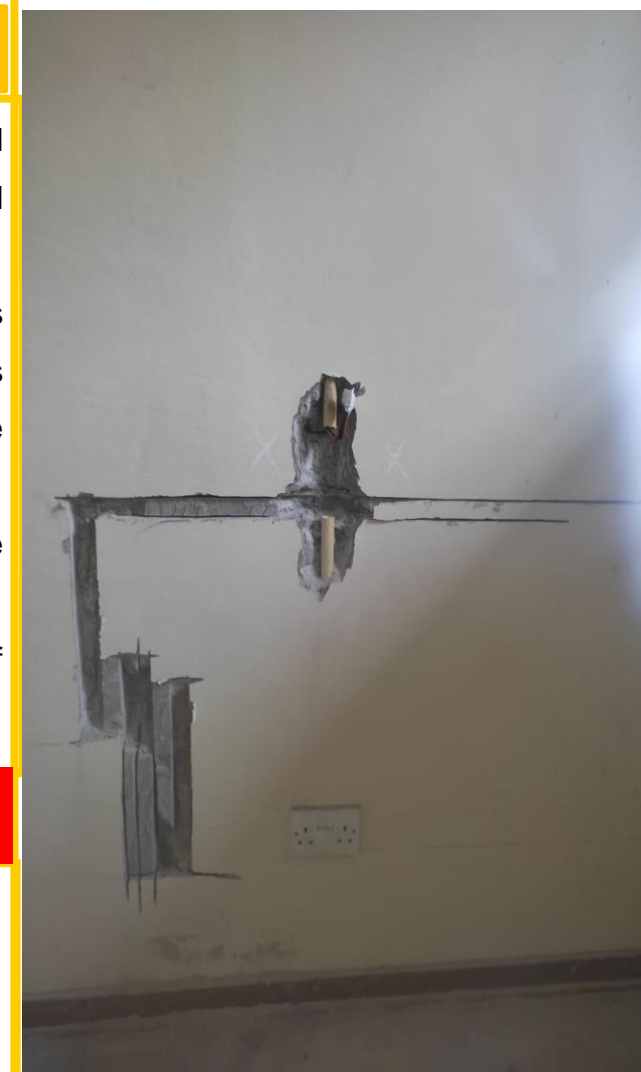
Conduit electrical pipe with a live cable was cut off with a baby grinder during the preparation of the brick wall for installation of water copper pipes.

Damaged Conduit Pipe with Live Electrical Cable

- Electricians and the Plumber had identified the path of the conduit electrical pipe prior to work commencement.
- Unsafe act- There were no markings made on the wall to indicate the portions of the wall that were not supposed to be cut.
- Electrical isolation was not done as the wrong wall was cut.
- Security turnstiles temporarily went off following the incident.

- Work was stopped and the incident was reported to all relevant stakeholders.
- The damaged electrical cables were safely isolated by the electrician.
- Power was restored and the turnstiles were brought back online.
- The team was re-briefed on the incident and markings were made on the wall to indicate the portions of the wall to be cut.
