SHE Alerts 0052

SHE Incident Alerts

SHE ALERT

Section: Wellfields

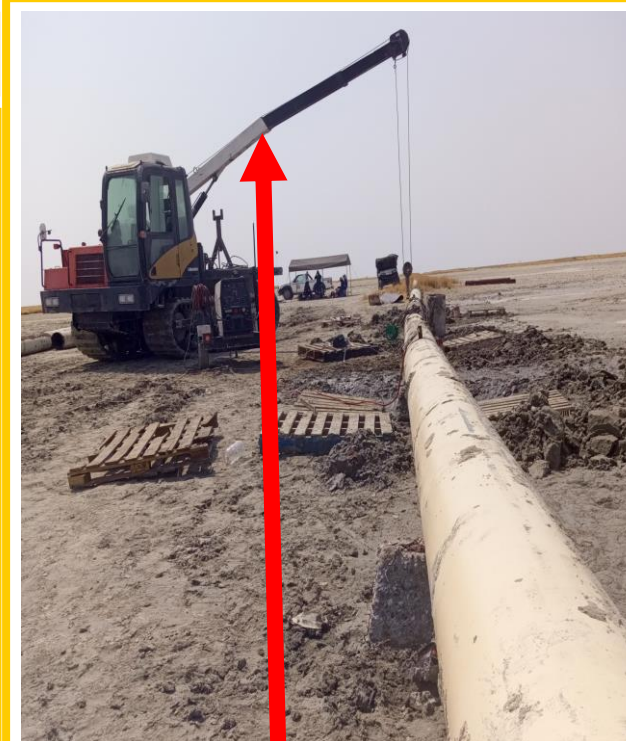
Damaged Part

Whilst lifting a pipe connected to the main line, the Morooka (E192) crane boom bent.

- Bent boom

- The lifting was done to place a wedge between the pipes to prevent back flow of water.
- The machine was positioned at least 4 meters away from the load and this resulted in the boom being fully extended reducing its lifting capability.
- The hoist-up crane is not fitted with a load limit sensor.
- There was no Rigger on-site at the time of the incident.
- The operator was in possession of valid authorization

- Work was stopped and the machine was discontinued from use.
- Riggers were engaged to assist with lifting.
- Another machine was brought in under the control and direction of leaders
