SHE Management
Incident Investigations
SHE Incident Alerts

SHE ALERT

Equipment:
Eyebolt on a motor

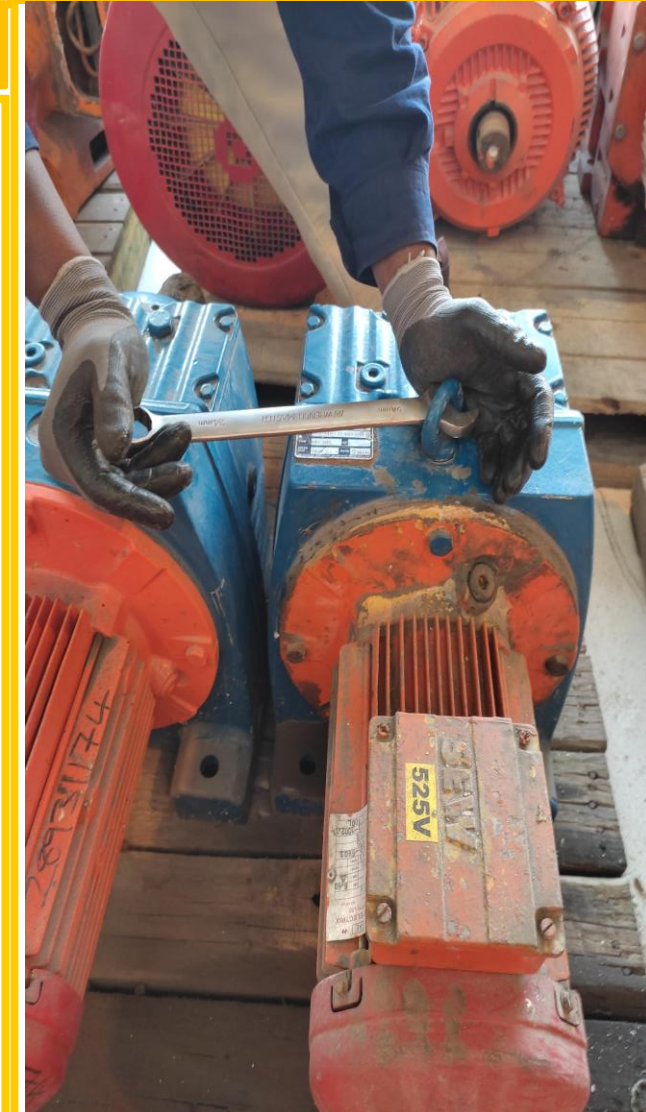
Whilst trying to unfasten an eyebolt from a motor using a spanner the injured's left palm got trapped between the eyebolt and the wrench resulting in a cut.

- The injured used the wrong tool to unfasten the eye bolt.
- The injured should have used a longer tool to unfasten the stuck eye bolt for leverage and safety.
- The eyebolt was stuck in the threads and broke as result of the pressure exerted on it

- The activity was immediately stopped.
- The incident was reported to relevant authorities.
- The injured was taken to the mine clinic for further assistance.
- The incident was briefed to all employees in the section.
- People must always use the right tools when performing a task.
