Property Damage

Soda Ash Bagging

SHE ALERT

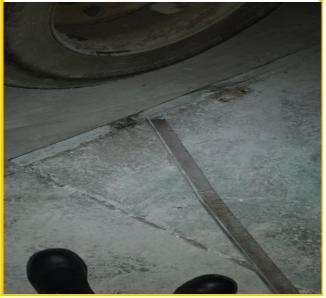
Whilst positioning his truck to load, a Smartways truck driver hit the Soda Ash handrail and punctured the front left tyre of his truck.

- The driver was Alco tested and the results were negative.
- The driver was in possession of a valid driver's license.
- The truck driver made a misjudgement whilst trying to position the truck and drove over the handrail.

- The activity was immediately stopped.
- The incident was reported to the relevant authorities.
- The tyre was replaced, and the truck was checked for defects before being allowed to load.
