SHE Alert SECTION SUB-SECTION **SUBJECT**

SHE Management Incident Investigations SHE Incident Alerts

Ground Pollution

Where? Sewage Treatment Plant

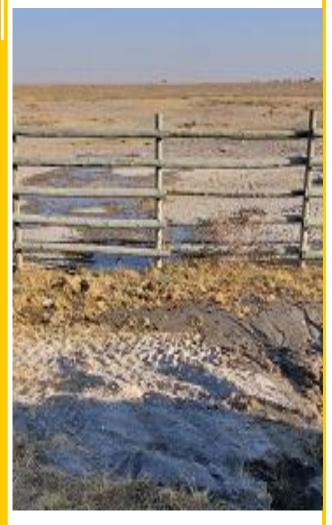
Sewage effluent overflowed from septic tanks resulting in pollution of surrounding environment.

Recycle sump found on high-high mode indicating high levels of water in the sump.

- Water level in all the septic tanks was high.
- The plant was running with trickling filter feed pump (PC 1001) and Clarifier feed pump (PC 1003) at the time of the spill.

- The incident was reported to the Supervisor and maintenance teams.
- The plant was by-passed to the maturation ponds to prevent further pollution of the environment.
- Troubleshooting commenced to identify and rectify the cause of the fault
