**SHE Alerts 0052**

**3800/FOR/0052**

SHE Incident Alerts

**Where?****Location :** MEA Plant  
**Section:** Utilities Plant**When?****Date:** 18/05/2023**Time:** 09:45hrs**Incident Description**

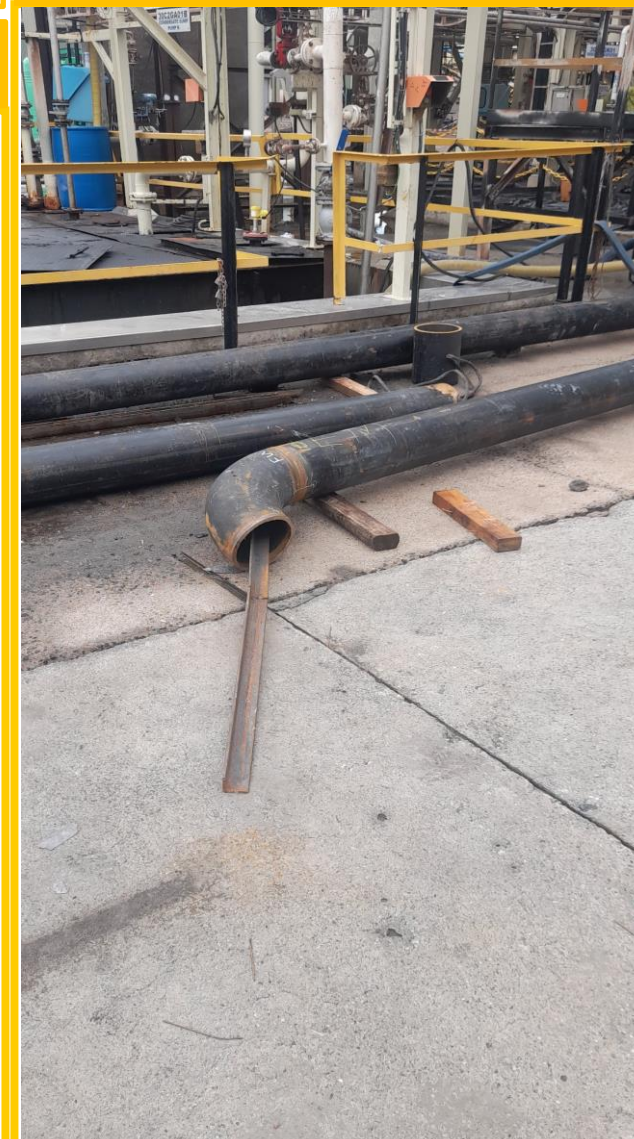
An Artisan Boilermaker sustained an abrasion cut on the vermillion border of the lip, after being hit by an angle iron that was used as a pivot to move the pipe and got stuck inside the elbow connecting to the condensate pipe during the lifting operation.

- Communication between the riggers and boiler maker was not clear.
- The Boilermaker was in the vicinity of the load where the lifting was taking place.
- The hazard of the angle iron was identified, and not eliminated as stated in the risk assessment.

- The injured was taken to the mine clinic where he was treated and sent back to work.
- Employees should always communicate and fully barricaded areas where lifting is to take place.
- Lifting of load using a crane, should not be done when there is someone within the vicinity where lifting is to be done.
