SHE Alerts 0052

SHE Incident Alerts

3800/FOR/0052

SHE Alert

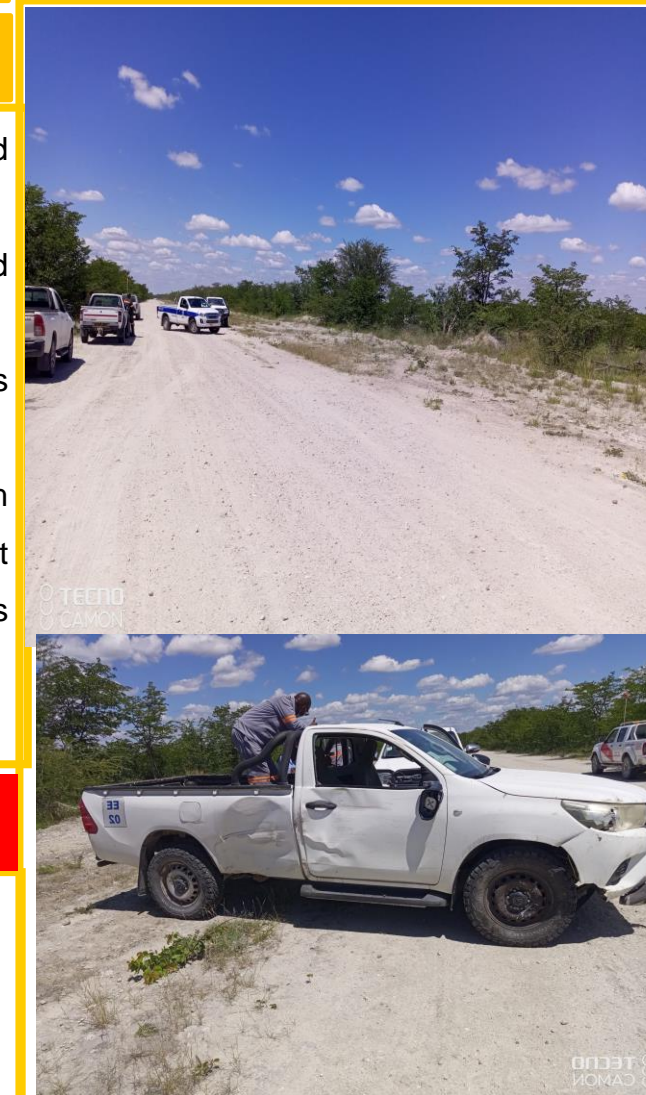
Whilst driving on a gravel road along the potable/brackish water pipeline a wellfield operator lost control of his vehicle and crashed into the nearby trees.

Dents on the right side bodywork, and a right mirror broken.

- The operator was in possession of valid authorization.
- Pre-start checklist was conducted and there were no defects on the vehicle.
- The driver was Alco Tested and results were negative.
- Overspeeding - Vehicle control system indicated (Telematics) indicated that at the time of the incident the vehicle was travelling at 105km/h.

- Relevant authorities were notified of the incident.
- The operator was taken to the mine clinic for further medical assessment and released back to work.
- Employees of the Section were briefed on the incident and sectional Baseline Risk Assessment (BRA).
- Operators of vehicles encouraged to adhere with stipulated road traffic speed limits.
