## SHE Alerts 0052

SHE Incident Alerts

**Location:** Eastern Stacker

**Section:** Salt Plant

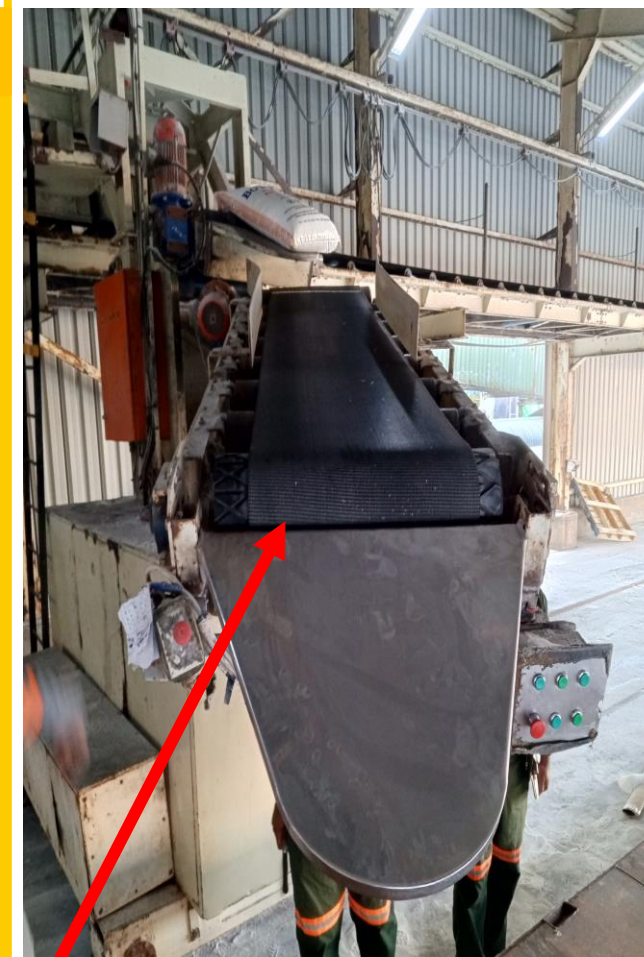
A temporary employee's right hand got trapped between the stacker discharge conveyor pulley and the discharge plate, resulting in an injury.

- The injured right-hand fingers went through the gap between the conveyor pulley and the discharge plate while trying to collect a fine salt 50kg bag from the discharge plate.
- The conveyor was stopped using the emergency stop button to free the injured's hand.
- The injured was putting on safety gloves.

The gap between the conveyor pulley and the discharge plate.

- The task was stopped, and the bagging crew was briefed.
- Increase the gap between the discharge plate and the conveyor
- The injured person was taken to Francistown Academic Hospital for further assessment and treatment.
