SHE Management Incident Investigations **SHE Incident Alerts**

SHE ALERT

Incident Description

Whilst carrying new empty bags from Procurement a Front-End Loader (FEL) hit an LDV on the road infront of the LBB yard.

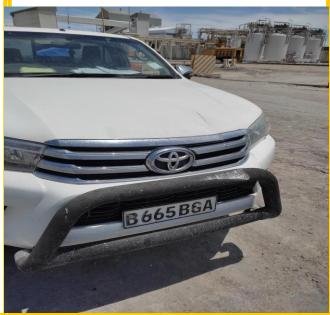
Pictures

Nudge bar and bonnet cover of LDV

- Prestart checklists for both machines had been done, and the machines were safe for use.
- Both operators of the machinery have valid authorizations.
- Use of wrong equipment- the FEL was used to carry stacks of empty bags which forced the operator to lift the bucket higher obstructing his view.
- Unsafe Act the FEL operator continued with the task despite the bags obstructing his view.
- The LDV was carrying unsecured loads (Oil Drums) which fell on the side prompting the driver to stop.
- Negligence the LDV driver parked his vehicle in the middle of LBB road to fix the drums which had fallen off taking the without necessary precautions.
- The driver of the LDV and FEL were alco tested and the results were negative.

- The incident was reported to the relevant personnel.
- Salt Plant and Garage employees were briefed on the incident.
- Re Brief employees Salt Plant and Garage employees on MQWM Act Reg 26.29 & 30
- Operators of mobile equipment must always park them in a safe area.
- All loads must be secured when being transported.
- People must always use the right equipment when performing their tasks
- Employees must take responsibility for their own safety and that of others at all times
