SHE Alerts 0052

SHE Incident Alerts

SHE ALERT

An employee sustained a contusion on his right shoulder after a minibus he was driving overturned whilst driving from Sowa township to the Mine.

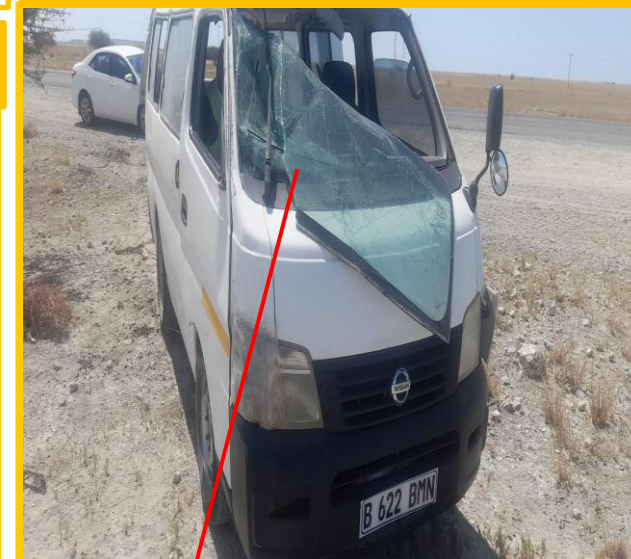
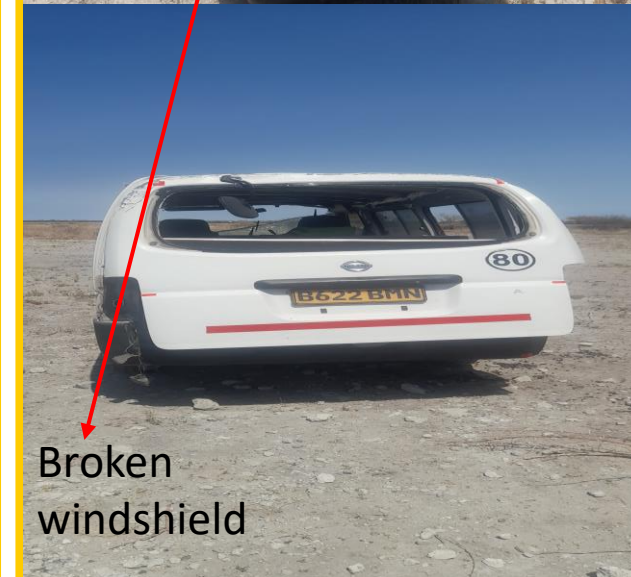
Property damage – broken windshield

- The employee was on his 12th day without rest.
- The employee fell asleep whilst driving the minibus.
- The incident happened within the lease area.
- The injured was alone in the minibus.
- The employee was also tested and the results were negative.
- Pre- start checklist was conducted for the minibus.
- The employee's driver license and authorization was overdue for renewal on the 31/08/2023.

Broken windshield

- Employees must always adhere to the required speed limit.
- Employees must not drive if they feel unfit to drive.
- All employees must adhere to employment act which talks to having a rest after seven working days.
