**SHE Alerts 0052**

SHE Incident Alerts

Where?**Location:** Road Hopper**Section:** Salt Plant**When?****Date:** 30/05/2023**Time:** 15:20hrs**Incident Description**

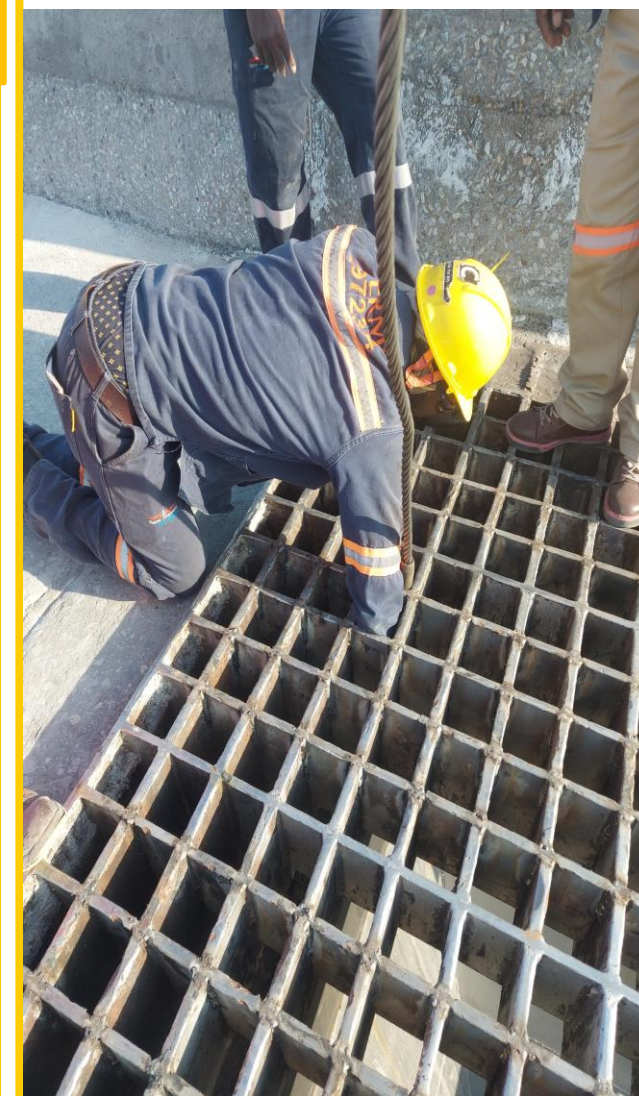
An Artisan Rigger sustained an injury on his left-hand thumb after it got trapped between the sling and load whilst lifting the grizzly at the Salt Plant Road Hopper.

Left hand thumb (burst laceration)

- Two slings (4m x 3.6t) anchored on a 100T crane were inserted through the grizzly bar openings.
- Metal bars were slot in through the slings eye underneath the grizzly to maintain grip on the load.
- Whilst tensioning the slings prior to lifting, the Rigger's left hand was holding the metal bar to prevent it from sliding off position resulting in his thumb being trapped between the sling and the metal bar.
- There are no lifting lugs on the grizzly bars.
- The injured was wearing leather gloves.

- The injured was taken to the mine clinic for medical treatment attention.
- A new approach was adopted to safely lift the drizzly bars without exposing the hands or fingers to nip points
- Employees must always be attentive when performing tasks and must keep their fingers away from nip points.
