SHE Alerts 0052 **SECTION** SHE Management SUB-SECTION Incident Investigations **SUBJECT SHE Incident Alerts**

SHE ALERT

Location: Soda Ash

Section: A Calciner double mixer shaft

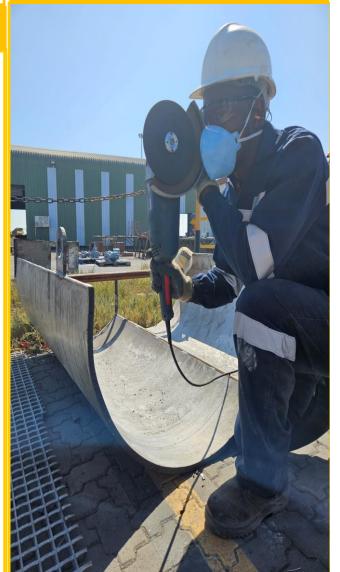
Picture

A semi-skilled Boilermaker sustained a cut on his left eyelid after being hit by a grinder whilst cutting the double mixer shaft shell.

Cut on the upper left eyelid

- The injured has 4 years work experience and was involved in pre shutdown work.
- Risk Assessment and Stop, Look, Assess and Manage (SLAM) checklist were adequately completed.
- Whilst cutting the double mixer shaft shell the grinder recoiled and hit the employee on the face damaging his safety glasses resulting him in sustaining a cut on his eyelid.
- The injured was cutting the last shell (3 had already been cut).
- The injured was working in a confined space.

- First aid was administered, he was taken to the clinic for medical assistance and referred to Francistown for further assessment.
- Before working with power tool's, one must ensure they are in good condition and put on applicable PPE.
- When operating power tools employees must remain vigilant.
- One must position themselves appropriately relative to piece they are working on such that if there is sudden movement of the power tool they can avoid harm.
