SHE Alerts 0052

SHE Incident Alerts

SHE ALERT

Location: A Calcliner incline conveyor

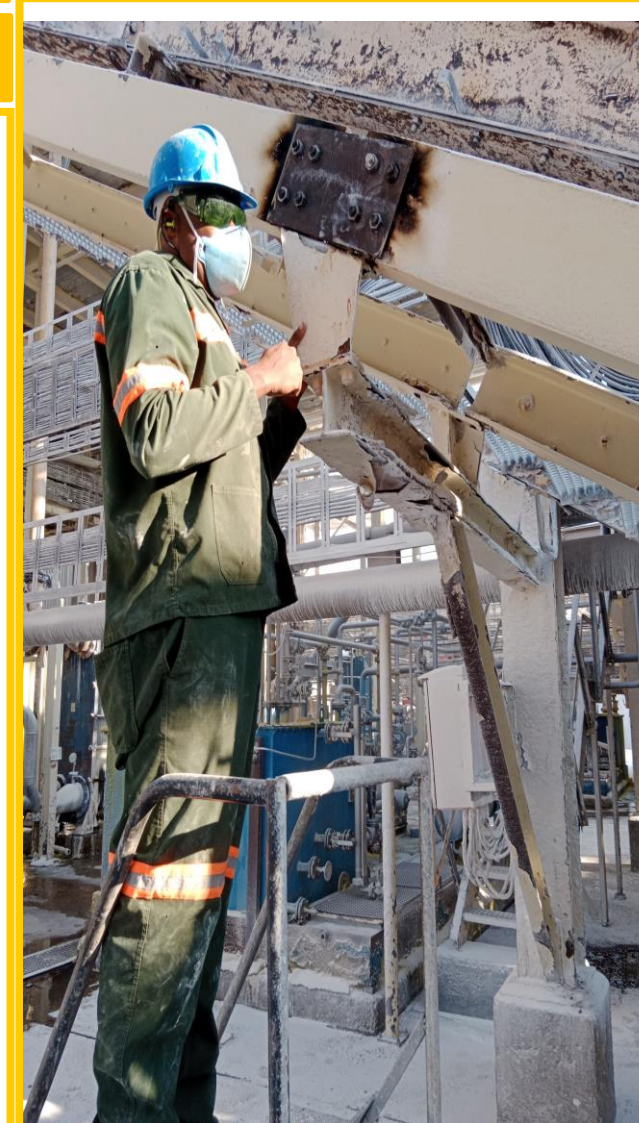
Pictures

Whilst a semi-skilled boilermaker was fastening bolts on the bracing plate for the incline conveyor staircase, the spanner slipped from the bolt head resulting in him losing balance. He fell off the stairs platform, at a height of 930mm, on which his leg was trapped between the staircase rungs.

- The stairs platform was not placed in suitable position to perform the task in a safe manner.
- The spanner slipped from the bolt head, the injured lost balance and fell off the stairs platform. Whilst falling his left leg got caught in-between the rungs.
- The injured was also tested and the results were negative.

Fracture below the left knee

- The incident was reported to the relevant personnel.
- First aid was applied to the injured and he taken to the mine clinic for further assistance where he was transferred to Francistown Academic Hospital.
- Employees of the section were briefed of the incident to make them aware of the potential hazards associated with the task.
- When fastening bolts, one must assume a stable standing posture to avoid falling should a spanner slip from a bolt head. Supervisors to monitor and coach their subordinates periodically.
- Enlarge the last rung of the platform to increase support for users.
