SHE Alerts 0052

SHE Incident Alerts

Fire Incident

Location : PW 131

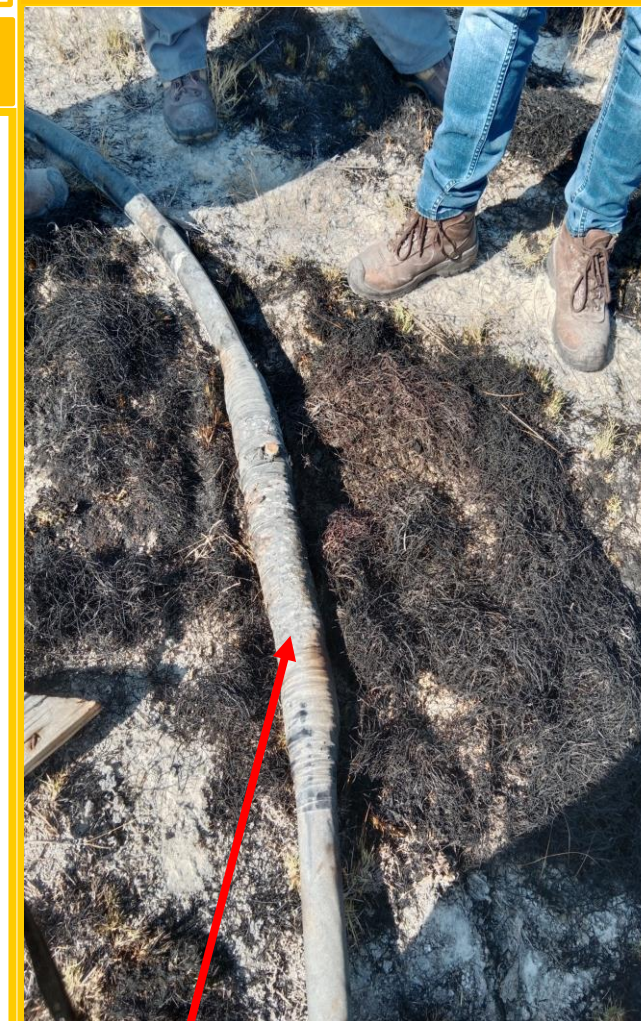
An 11 kV XLPE cable joint blew up and its sparks landed on the surrounding grass which ignited and causing fire at the Wellfield PW 131.

- Burnt 11kV XLPE cable

- The XLPE cable joint failed due to wear and tear.
- Cable joint got exposed over time from underground
- Over the years, grass has grown on the pan surface.
- Approx 1 hectare of grass was burnt.

Exposed cable joint

- The relevant authorities were notified.
- The Emergency team was dispatched to the scene and the fire was extinguished.
- Fire breaks around wells which are surrounded by grass must be constructed.
- All cable joints to be buried underground, to prevent risk of fire should they fail.
