SHE Alerts 0052

SHE Incident Alerts

SHE ALERT

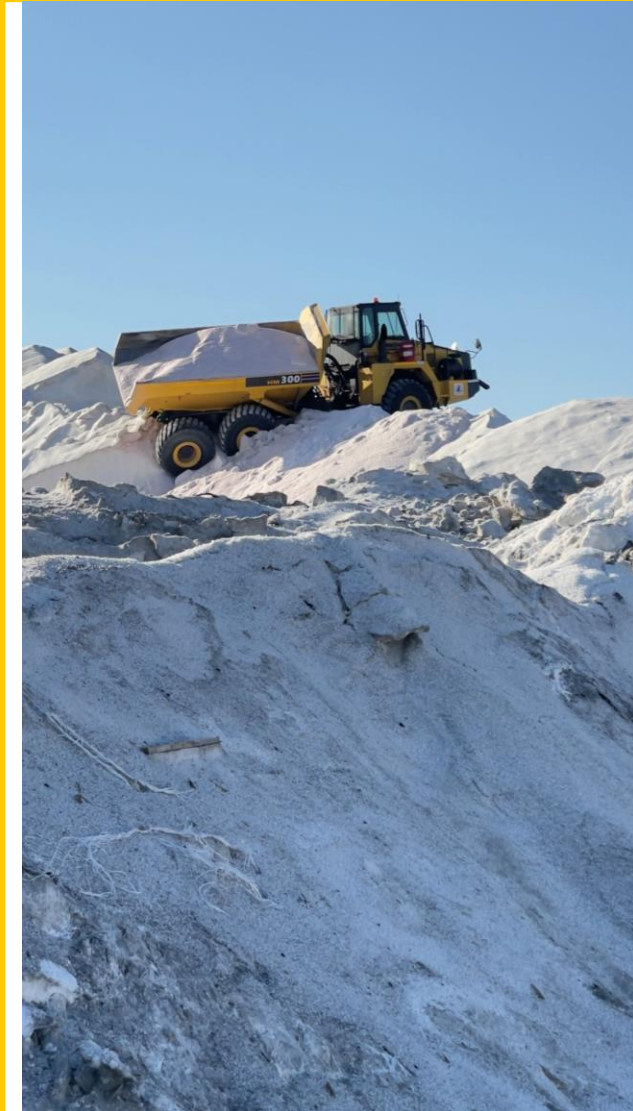
Pictures

The Botash dump truck almost fell off the salt piles when the truck reversed over the berm.

No damages

- The operator was getting ready to offload the first load at the washed salt stockpile.
- The operator reversed beyond the offloading point.
- There were no injuries sustained.
- The operator had valid authorization to conduct the operation.

- Employees must ensure good communication during task execution.
- Employees must ensure that all the risks identified during work are mitigated adequately.
- A recovery team was established to ensure safe retrieval of the machine.
