SHE Alerts 0052

SHE Incident Alerts

SHE ALERT

Section: Soda Ash plant

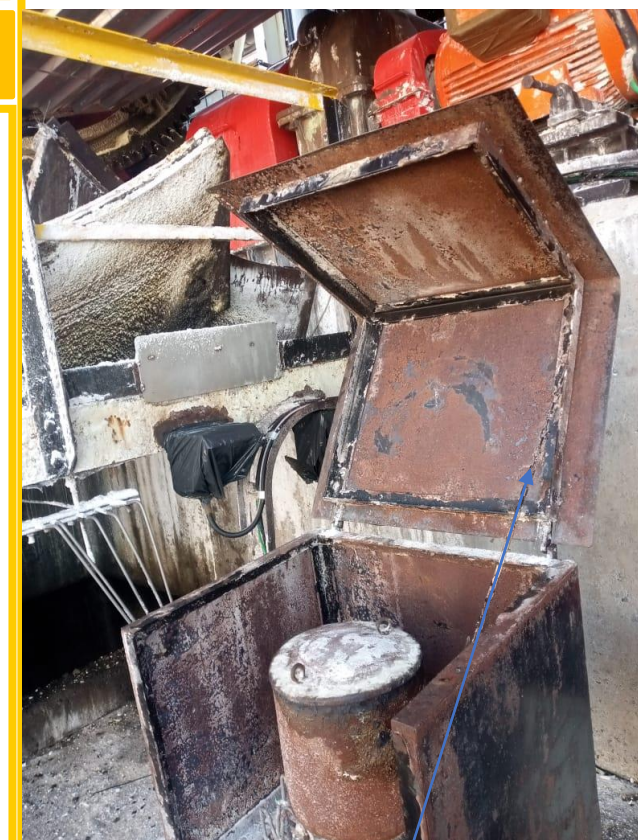
Whilst Semiskilled fitters were replacing steam head oil pump motor, the lid of the motor housing closed and hit one of the employees on her lower left back.

- One of the fitters accidentally touched the support chain of the housing lid and it closed hitting the fitter on her back.
- **Design of the equipment** – The motor housing has a support chain which holds the lid in place however, if accidentally touched it also poses a risk of closure.

Support chain of the motor housing lid

- Work was stopped immediately
- The incident was reported to the responsible personnel.
- The injured was taken to the clinic for further medical assistance.
- A stopper was placed between the housing and the lid to prevent unplanned closing during work.
- The incident was briefed to section employees
