SHE Alerts 0052 **SECTION** SUB-SECTION **SUBJECT**

Safety First! SHE ALERT

Incident Description

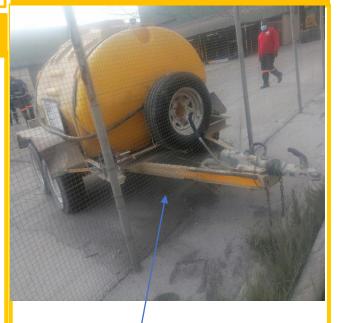
Whilst being towed from the Garage Workshop, a diesel bowser trailer decoupled from an light duty vehicle (LDV) and crashed into the Stores fence.

- of attention The Lack operator did not ensure that the trailer latch was fully secured on the LDV.
- Use of defective equipment The safety chain of the trailer was broken.
- The was no fire extinguisher on the diesel bower.
- The driver was in possession of a valid driver's authorization.
- The driver was alco tested and results were negative.

Damaged stores fence

- The incident was reported to the relevant personnel.
- The diesel bowser trailer was put out of use until all defects identified are fixed
- The section was briefed on the incident.
- Employees must not use defective equipment.
- Employees must be fully engaged when performing their tasks.
- Conduct a minewide inspection of all bowsers to ensure they comply.
