SHE Alerts 0052

SHE Incident Alerts

SHE ALERT

Section: Utilities Plant

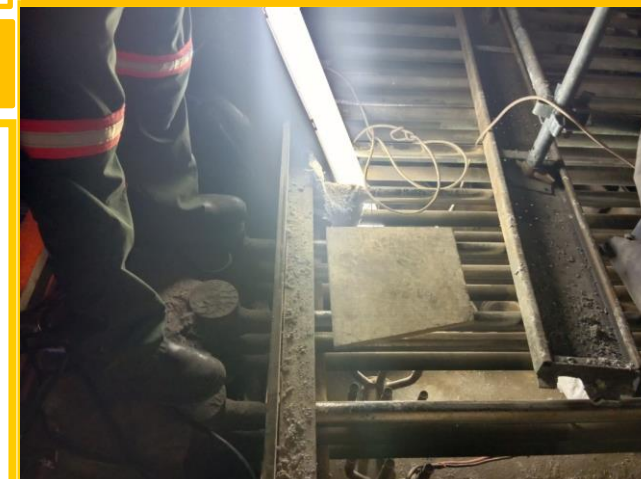
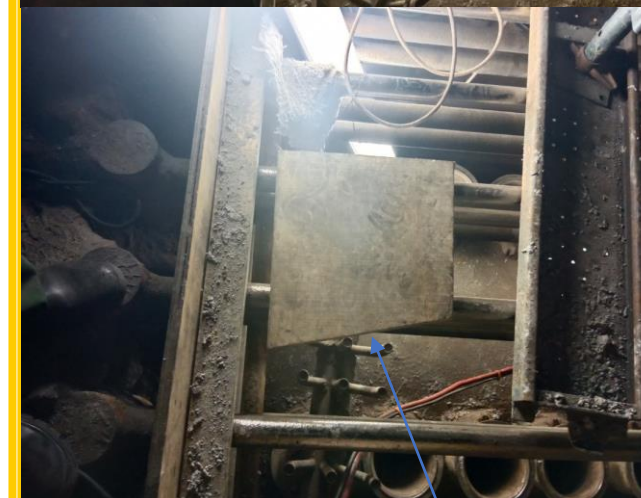
Pictures

A temporary employee sustained an abrasion on his right shin after his leg went between the boiler tubes when he stepped on the edge of a shutter board that was used as walking platform in boiler 1.

- **Inattentiveness** - The injured was not paying attention whilst walking, he stepped on the edge of the shutter board and his leg went through the boiler tubes.
- The shutter board was not covering the whole walking platform.

Shutter board used for providing walking platform on the boiler tubes

- Work was stopped immediately
- The incident was reported to the responsible personnel.
- The injured was taken went to the clinic for further medical assistance
- Employees must always remain alert when working.
- The incident was briefed to section employees.
