SHE ALERT

Whilst trying to lift a cable drum it rolled from the forklift and damaged the Stores backyard parameter wall.

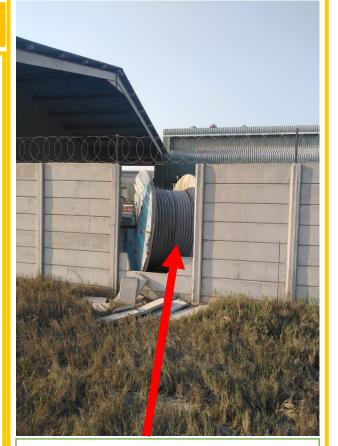
- Prior to the incident the team had unreeled 30m out of 110m of PILC electrical cable (95mm x 3).
- To prevent the cable from kinking, the team lifted the cable drum using a forklift and it rolled and hit the dura wall.
- Use of wrong equipment- a forklift instead of crane was used to lift cable the drum.

Dura wall

Damaged Area

- Actions Taken Following The Incident
- Work was stopped and riggers were engaged to reposition and place the cable drum on the stand.

• Civils crew was dispatched to restore the damaged wall.
