SHE Incident Alerts

Location: Coal

SHE ALERT

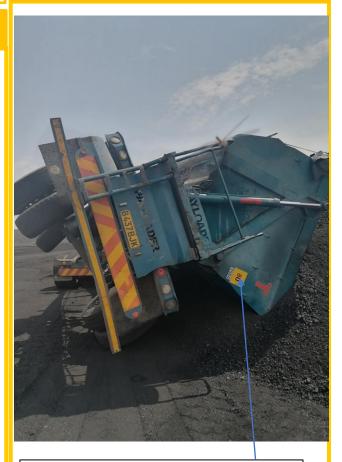
Whilst offloading coal ,the rear bucket of the truck tilted into the coal stockpile and fell on its side.

Hydraulic hose

- Hydraulic hose on the boom failed.
- The operator was in possession of a valid driver's license.
- The operator was also tested and results were negative.
- Pre-start checklist was not conducted on the truck.

bucket of trailer

• Supplier hosts to inspect all contracted trucks to ensure they are fit for use.
